January 12, 2016

**Re: Warren Steel Holdings
Notice of Violation (NOV)
NOV
RCRA C - Hazardous Waste
Mahoning County
OHR000007773**

Subject: Complaint Investigation and LQG CEI NOV

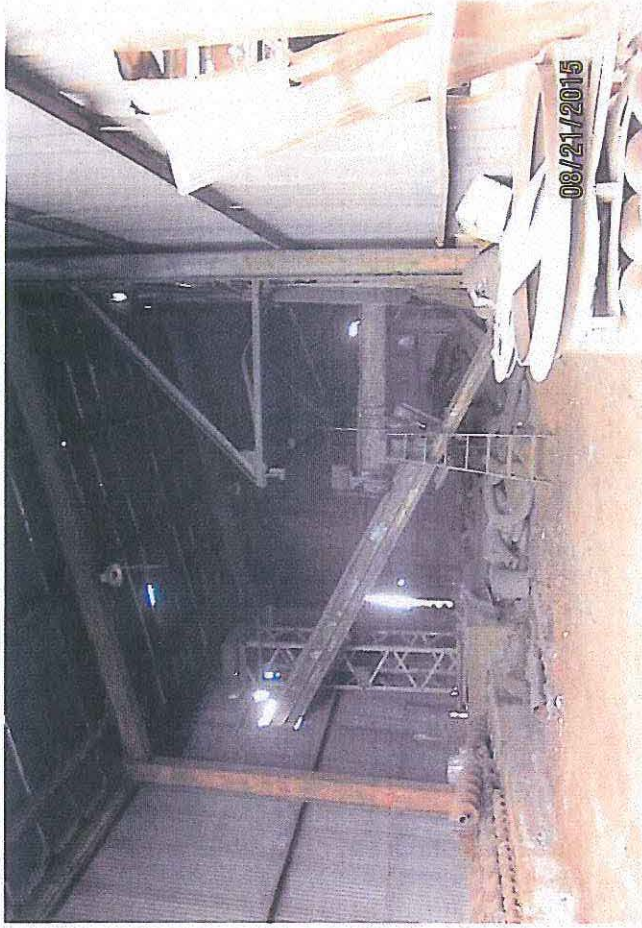
- c.) EAF dust was leaking from the inclined conveyor at the outlet of the baghouse onto the ground. Your status update on 9/16/15 indicates that the leaked dust was shoveled and vacuumed up by Odyssey Environmental Services and properly disposed. You have instructed your baghouse operator to perform thorough inspections and submit work orders as needed regarding maintenance items.
- d.) EAF dust appeared to be leaking from the connection of the baghouse outlet to the hazardous waste container. Please indicate how you have addressed this issue.
- e.) Any EAF dust that leaks from the baghouse can escape to the soil around the baghouse. The soil surface around the baghouse has the color, consistency and appearance of fugitive baghouse dust. Please indicate how you have addressed this issue.

- 6950 – Horizontal screw auger from baghouse discharges EAF dust onto enclosed inclined conveyor that moves the EAF dust to vac box outside. EAF dust is leaking from the conveyor and piling up on the ground behind the ladder. We were told there used to not be a conveyor and the EAF dust used to just pile up on the ground in this area.

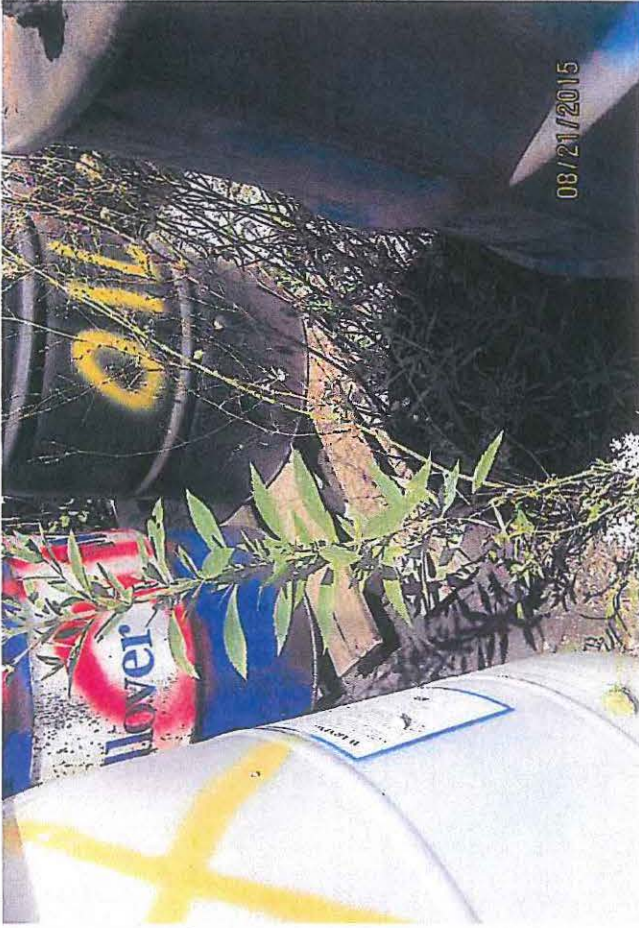
6980

badly bulging and some were leaking black oily wastes onto the ground. In particular, a black oily liquid had been released from a drum labeled "used oil". (See photos #6979-6995.) Most drums were stored upright but some were lying on their side. Most drums had lids but some didn't and some lacked bungs. Most drums were on pallets but some weren't. John stated they needed to get rid of all of these containers and I explained that they needed to clean up the visual staining of the ground from used oil releases and again that all used oil containers need to be labeled "used oil".
